CHECK OUT REPORT

Sample check out report - PROPERTY ADDRESS

A check out inspection has been carried out referring to an updated Inventory dated 21st September 2010 and apart from any stains, marks etc. indicated on the check in the following observations were also made:

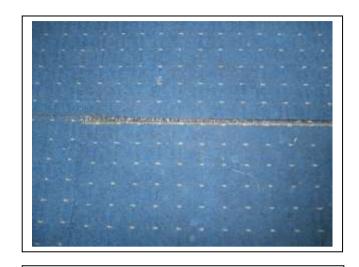
Hall/Lounge carpet

- Handle off to inside of front door, dirty marks inside
- Window dusty to frame, dirty stains to sill
- 1 blind by kitchen snagged and twisted to ends
- Light shade changed to light blue card shade
- Dirty marks to walls throughout, stain/run marks to partition walls, chipped on corner edges, heavy on entrance, poor condition
- Skirting board dirty
- Sockets and switches dirty
- Brown dirty stain marks to carpet, white paint line mark by kitchen, rucked badly along join by kitchen, heavily fraying with large gap on same join, dirty marks requires cleaning and repair
- Dirty marks to radiators, 4 caps missing
- Dirty marks to door on cupboard

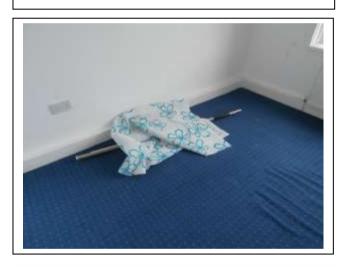
Bedroom 1

- Dirty marks to both doors and frames
- Window frame dusty to top
- Blind broken off and loose to floor
- Brown dirty marks to walls by outer door and by window, grubby marks throughout poor condition
- Hardened stain mark to carpet on entrance, heavily rucked in centre, odd hardened marks, odd white paint marks requires cleaning
- Dirty remains and marks to radiator

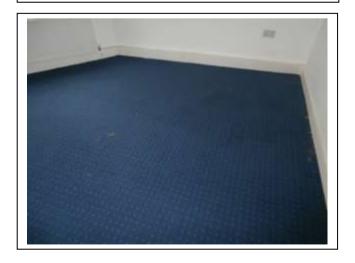
Bedroom 3 Carpet

- Light grubby marks to door
- Blind frayed on bottom
- Light shade changed to red shade
- Odd pin holes and cream touched up marks to I/h wall, various small pin holes to r/h wall with odd small chips to plaster, grubby/dirty marks throughout
- Skirting board dirty along top edges
- Carpet rucked to right, some dirty stain marks, light brown debris, odd black and light blue marks, odd paint mark requires vacuum and cleaning
- Dirty marks to radiator

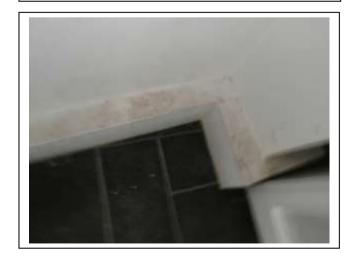
Kitchen Skirting Board

- Window frame dusty and dirty
- Blind fraying and snagged to edges
- Light shade changed to light brown shade
- Dirty marks to emulsion walls, heavy by fridge, dirty to tiles
- Skirting board very dirty
- Odd red paint spot marks to vinyl floor, debris, dirty
- Dirty marks to radiator
- Kitchen units stained and dirty, food splash marks to fronts requires cleaning
- Sink dirty
- Fridge freezer dirty
- Extractor hood dirty
- Oven with heavy burnt on remains, dirty and greasy requires extensive cleaning
- Hob with heavy burnt on remains to stands and rings requires cleaning
- Washing machine dirty, dispenser heavily soiled

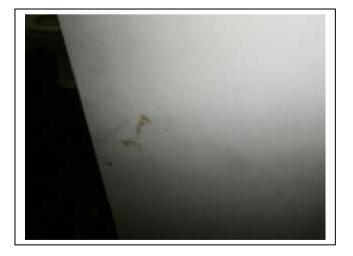
Bathroom Walls

- Dirty marks to door and frame
- Window frame and glass dirty
- Light not working
- Paint blistering to emulsion wall by sink, extractor fan and by end of bath, dirty marks throughout, tiles water scaled and dirty – require cleaning
- Skirting board dirty
- Floor sticky under foot, white stain marks, dirty, boards underneath seem loose on entrance
- Dirty marks to radiator
- Sink and toilet dirty require cleaning
- Dirty to side panel of bath and base, water scaled, wooden panel at end water damaged requires cleaning
- Heavy pink staining to shower curtain
- Mirror dirty
