# Sussex Inventories

## INVENTORY AND SCHEDULE OF PLIGHT AND CONDITION

1<sup>ST</sup> OCTOBER 2012

<p><b>Brief description of property</b></p>	<p>1 bedroomed furnished flat on 1<sup>st</sup> floor in a fair decorative order                  The property has been cleaned to a fair domestic standard                  The carpets have been vacuumed only                  None of the electrical appliances have been checked as to working order.</p>
<p><b>Time and weather at attendance</b></p>	<p><b>Time:</b> 10am  <b>Weather:</b> Dry &amp; Overcast</p>

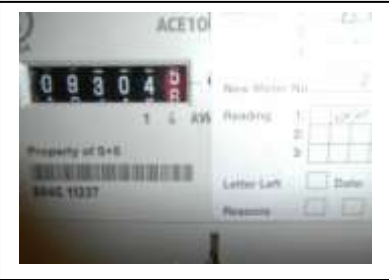
**Electric Meter**

**Readings:** 09304

**Location:** Lobby meter cabinet

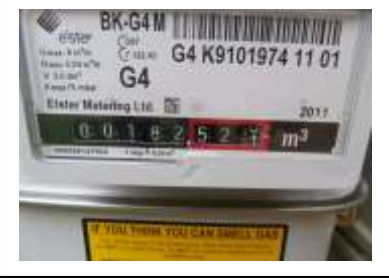
**Gas Meter**

**Readings:** 00182

**Serial Number:** K99101974

**Location:** Outside

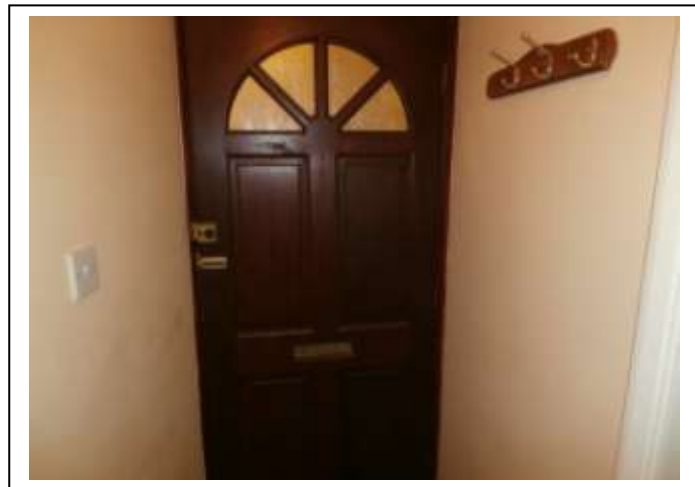
## ENTRANCE & HALLWAY

ITEM	DESCRIPTION (CONDITION)	COMMENTS IN/OUT
<b>Front Door</b>	Dark wood stained panelled with 4 patterned glass panels to top, brass knocker, brass letterbox cover, brass No.98 to outside, brass plated Yale lock with brown catch to inside (various small scratch marks to outside at low level, slight white splash paint marks and spray marks and small gauge to centre, odd marks to edge, surround of lock askew) Dark wood stained doorframe	
<b>Ceiling</b>	White painted patterned artex with white plastic loft hatch, smoke alarm (grubby marks to hatch)	
<b>Lights</b>	Single pendant with white round paper shade bulb (rose over-painted)	
<b>Walls</b>	Magnolia painted emulsion with light wooden plinth with 3 brass coloured double coat hooks (1 hook broken on plinth, scuffing to mid-low level to either side, heavier by front door, patchy marks bedside light switch, screw protruding out of plinth/coat rack, old defects over-painted) Off white painted wood skirting board

<b>Switches &amp; Sockets</b>	Single white light switch Single white power socket	
<b>Floor</b>	Cream fitted carpet (shading and wear, greyed on entrance to bathroom, bedroom and through centre, greyed to edges, light spot marks, vacuumed only)

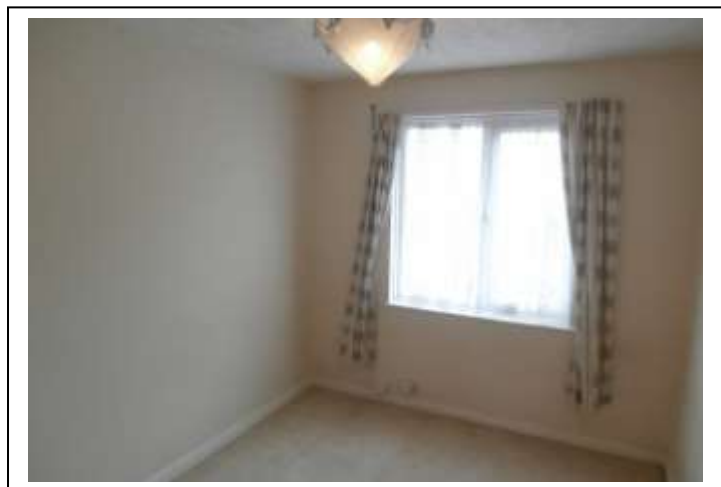
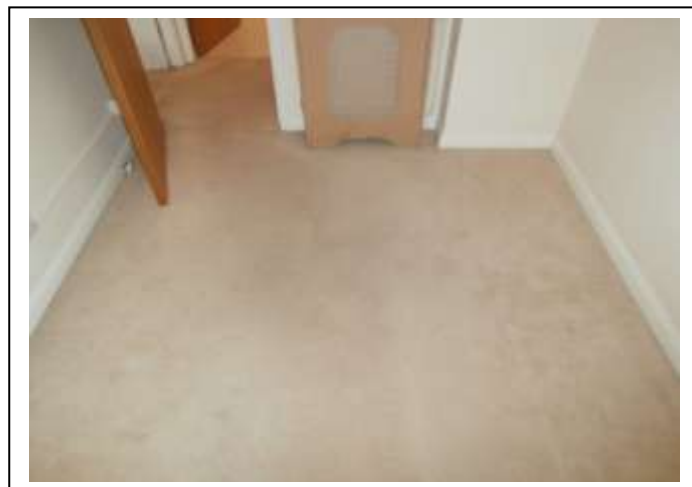
## BEDROOM

ITEM	DESCRIPTION (CONDITION)	COMMENTS IN/OUT
<b>Door</b>	<p>Light wood grained sapel with 2 chrome lever handles, chrome round plate to either side, brown wooden plinth with 6 brass coloured double coat hooks (plinth loose to wall still with plastic on, various white filler marks to centre at top on inside and to edge, various scratches, blackened to edges, varnish worn off in places, small chip)</p> <p>Off white painted wood doorframe with patterned glass panel above (little loose to edge)</p>	
<b>Windows</b>	<p>White UPVC with single white closure with lock (light grey staining to all of frame, little blackened in corners, light dust)</p> <p>Off white UPVC window frame (slight staining to seal, frame discoloured)</p>	
<b>Window Dressing</b>	<p>2 cream/beige patterned lined curtains on white plastic track (track slightly discoloured, fair condition, track coming away from wall to l/h side, not freshly laundered)</p> <p>Single white patterned net on white wire (greyed)</p>

<b>Ceiling</b>	White painted patterned artex	
<b>Lights</b>	Single pendant with blue shade and bulb	
<b>Walls</b>	<p>Magnolia painted emulsion (light shading to left hand wall, patchy shade marks to r/h wall at mid level, 4 holes and 4 pin holes to r/h wall, 2 with screws, scuffed to mid-low level, heavy scuffing to l/h corner, 2 terracotta marks, track line under window, various pin holes, grubby marks, orange mark to l/h wall, tired condition)</p> <p>Off white painted wood skirting board (odd marks, discoloured along top)</p>	
<b>Switches &amp; Sockets</b>	<p>2 white single power sockets (discoloured)</p> <p>Single white light switch (discoloured)</p> <p>Telephone socket</p> <p>Television junction box (loose to wall)</p>

ITEM	DESCRIPTION (CONDITION)	COMMENTS IN/OUT
<b>Floor</b>	Continuation of cream fitted carpet with chrome door strip (furniture marks, shaded, greyed to edges, heavy grey shading through centre, 2 cream marks on entrance, small pink and yellow mark in centre, odd light stains throughout, fair condition, vacuumed only)	
<b>Heating</b>	Single white panelled radiator with light wooden unpainted MDF radiator cover (1 end cap missing, odd marks to front, dusty to radiator, splash marks to cover at bottom)  Cream/grey Dimplex wall mounted fan heater with cord pull on white end (front slightly discoloured, dusty)

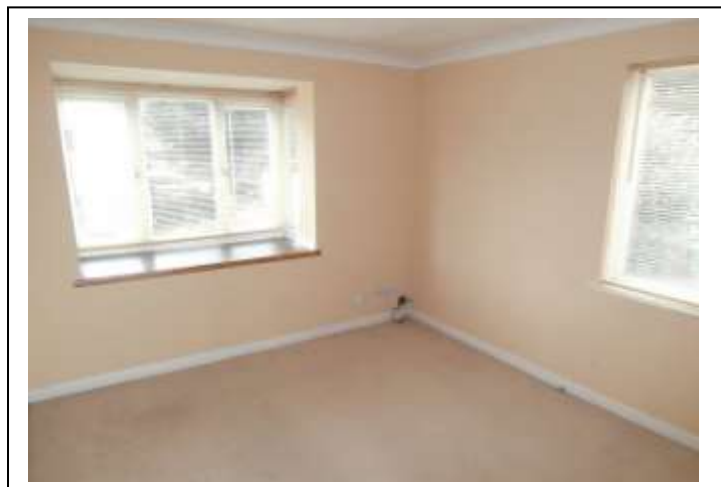
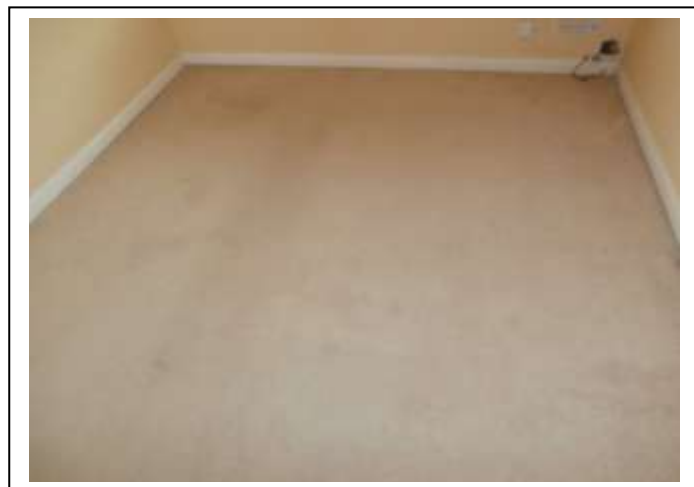
## LOUNGE

ITEM	DESCRIPTION (CONDITION)	COMMENTS IN/OUT
<b>Door</b>	Off white painted emulsion to outside, light wood grained sapel to inside and edge with 2 chrome lever handles, 2 chrome round plates (scuffed marked inside and out, various over painted indent line marks, odd chips to outside and edges, scuff line mark to outside) Off white painted wood doorframe with patterned glass panel above (scuffed chipped to edges)	
<b>Windows</b>	White UPVC bay with 2 white closures with locks (lightly greyed to all of frame, quite heavily blackened with condensation in corners, glass little dirty outside) Single white UPVC (faint grey staining to edges, light condensation) White UPVC window frame (all with grey staining) Brown/black leather effect windowsill with light wooden trim on bay window (odd over-paint and splash marks and wear to wood) Off white painted wood windowsill	
<b>Window Dressing</b>	4 cream plastic Venetian blinds each with drawstring and plastic ends (good order) Single matching window length curtain on white plastic track (slightly creased and discoloured)

<b>Ceiling</b>	Off white painted patterned artex with white coving (nail hole to left on entrance, greyed and cracking above bay window)	
<b>Lights</b>	Single bayonet with bulb and green/brass coloured fanned up lighter shade and bulb (shade creased and marked, dusty)	
<b>Walls</b>	Cream painted emulsion (patchy marks/scuff line marks to low level throughout, touched up marks in slightly different shade throughout, furniture marks to l/h wall, scuffing to mid level either side of small window, patchy marks, shading and scuffing to mid level, white filled holes left of kitchen, 1 picture hook, odd pin holes, 4 brass pins on facing wall, unpainted area and holes where junction box removed) Off white painted wood skirting board (scuffed and discoloured, light condensation in corners by window)

ITEM	DESCRIPTION (CONDITION)	COMMENTS IN/OUT
<b>Switches &amp; Sockets</b>	Double white power socket, 2 single white power sockets (slightly discoloured to front) Single white light switch 2 telephone sockets Single television socket, single brown cable coming through wall and running loose to floor Cream Honeywell thermostat control (cracked through centre) 2 black Sky TV cables coming through wall and loose to floor (ends missing)	
<b>Floor</b>	Continuation of cream fitted carpet with chrome door strip (light furniture marks to carpet, shaded, some heavy grey shading to walkway and from hallway to kitchen, grey spotting/staining on entrance and leading to kitchen, small pink mark to left, heavier shading/greying to walkways, vacuumed only)	
<b>Heating</b>	Off white double panelled radiator (small light marks to top edge and front, 1 end cap missing, discoloured to edge)

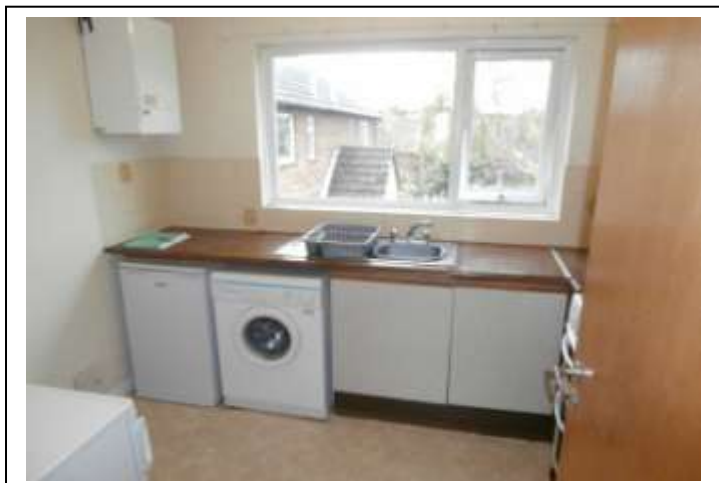
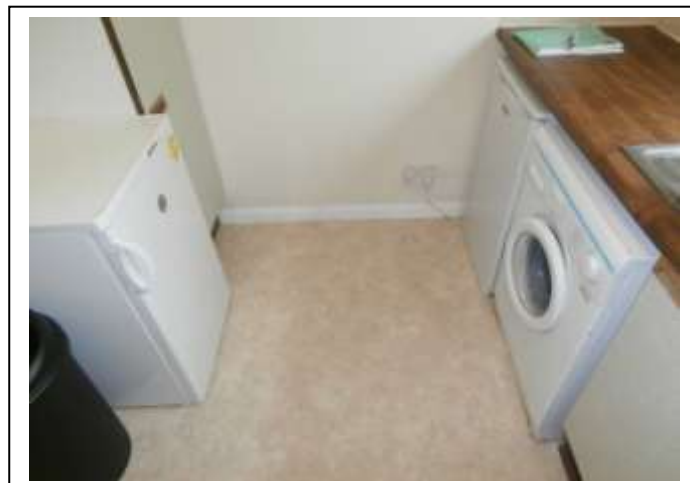
## KITCHEN

ITEM	DESCRIPTION (CONDITION)	COMMENTS IN/OUT
<b>Door</b>	<p>Light wood grained sapel with 2 chrome lever handles, 2 chrome round plates to either side (chrome slightly tarnished and marked, various black grubby marks to outside and to edge, paint marks to inside, worn and faded, long scratch mark to outside, worn and faded)</p> <p>Off white painted wood door frame with patterned glass panel above (glass slightly yellowed, odd marks, light knot marks)</p>	
<b>Windows</b>	<p>White UPVC with single white closure with lock and key (frames greyed and discoloured, glass dirty outside, water marked inside, little grubby around closures)</p> <p>White UPVC window frame (seal discoloured and grubby/dirty to inside)</p> <p>Beige mottled ceramic tiled windowsill (1 tile cracked, grouting missing in places)</p>	
<b>Window Dressing</b>	White metal track (little discoloured)	
<b>Ceiling</b>	Off white patterned artex

<b>Lights</b>	Single white light with tube and clear plastic cover (1 end cap missing and discoloured, dead flies inside)	
<b>Walls</b>	<p>Magnolia painted emulsion with cream mottled patterned ceramic tiles around work surface, beige mottled 6 ceramic tiles behind oven (sticky marks to tiles below boiler, odd sealer marks, 1 white sticky hook and sticky remains to tiles below heating control, sticky remains on tiles above oven, light splash and run marks to wall on corner right of oven, paint cracking above oven, scuff marks behind door, light greasy spot marks to wall left of fridge, unpainted are around central heating control where changed)</p> <p>Off white painted wood skirting board (marked)</p>	
<b>Switches &amp; Sockets</b>	<p>Single power socket, double power socket, single cooker socket and switch (all slightly discoloured)</p> <p>Single white light switch</p> <p>Single fuse switch</p>

ITEM	DESCRIPTION (CONDITION)	COMMENTS IN/OUT
<b>Floor</b>	Beige mottled effect vinyl with chrome door strip (slight ridge mark on entrance and indented, round damage hole behind freezer with 3 brown marks, tear in left of fridge, odd light scuff mark, small round light indent marks through walkways and on entrance, dirty/grubby beside freezer, oven and grubby around other appliances)	
<b>Kitchen Units</b>	White MDF carcasses with light wooden grained trims with grey mottled Formica fronts, dark brown grained Formica work surface with single chrome joining strip, dark brown cork trims to bottom of units (units all showing wear and age slight cracking to inside in places, sealer around work surface cracking and missing in places, various marks, marks to shelves and drawers, odd dirty marks to edges of odd door and drawers, odd sticky mark to work surface)	
<b>Wall Units</b>	2 single cupboards (stained inside)

<b>Tall Units</b>	Single cupboard with 1 door and 1 pull-up door, inside 5 single shelves (6 nails holes to side, some touch up paint and blue tack to front, cracking to MDF/laminate on side)	
<b>Floor Units</b>	2 single cupboards, 3 drawers (worn and marked inside)	
<b>Appliances</b>	<p>White Zanussi freezer, inside 3 clear plastic drawer fronts (yellow sticker to front, crack to handle, slightly used condition, grubby marks to outside of door and handle, odd food remain to inside, requires defrosting)</p> <p>White Fridgemaster fridge, inside 3 door compartments, 2 white grilled shelves, clear plastic salad box and glass tray shelf, clear plastic fronted freezer compartment lid (fair condition, door rubber discoloured/grubby, stained and split, freezer compartment heavily iced up, door to freezer broken to 1 end)</p> <p>White Candy washing machine (scratch to front, dispenser soiled)</p> <p>White unnamed extractor hood with pull-up glass panel (no filter, discolouring around controls, dusty to top, glass greasy, aged appearance)</p> <p>White Belling electric oven with 6 white round controls, grill compartment and oven compartment, inside grill single chrome grilled tray, grill pan and tray, inside oven 2 chrome grilled shelves, sitting on dark brown cork panel (bottom sticky and greasy, browned around rings, light run mark to inside of glass door, light carbon remains to bottom inside, coating below controls starting to rust – requires additional cleaning)</p>

<b>Sink</b>	Stainless steel sink and drainer with chrome mixer tap (scratched and faded, heavy to bowl, browned around soak away, scaling to drainer and around taps)	
<b>Misc.</b>	<p>White Wickes RWB9 CW central heating timer control</p> <p>White Baxi wall mounted boiler (sticker mark to front, smeared to front)</p> <p>Wooden plinth with 3 brown tea towel suckers attached to unit beside cooker (worn)</p>

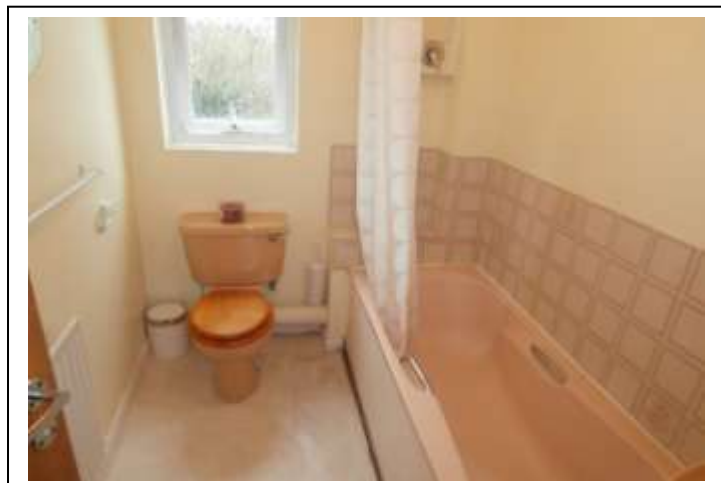
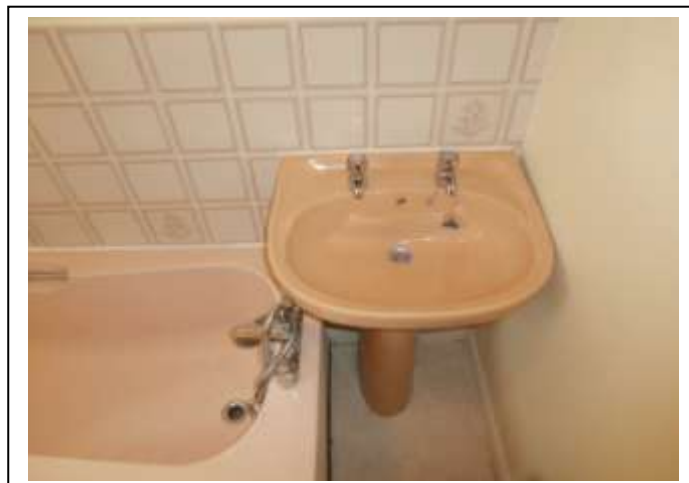
## BATHROOM

ITEM	DESCRIPTION (CONDITION)	COMMENTS IN/OUT
<b>Door</b>	Light wood grained sapel with 2 chrome lever handles, chrome plate to outside, black lock to inside (small off white plastic hook to inside at top with odd paint marks and blackened to edge, white paint marks to outside, faded and worn)  Off white painted wood door frame with patterned glass panel above (glass slightly yellowed)	
<b>Windows</b>	White UPVC with single white closure with lock (cap covering screws missing on right of closure, closure very loose, frame little discoloured, light chip to coating on closure, light condensation to edges, little dusty and grubby to bottom and edges)  White UPVC window frame (lightly discoloured)  Beige ceramic tiled windowsill	
<b>Ceiling</b>	Off white patterned artex (newly painted by window, faint condensation showing above bath)	
<b>Lights</b>	Single white round fitting with white round glass globe shade and bulb (paint cracking, debris to shade)

<b>Walls</b>	Light yellow painted emulsion with beige/brown patterned ceramic tiles around bath area and hand basin (emulsion looks recently painted over old light defects, tiles in a good to fair condition white plastic cup hook with tieback for shower curtain right of window)  Off white painted wood skirting board (condensation behind toilet, little discoloured/dirty by toilet)	
<b>Switches &amp; Sockets</b>	Single white ceiling rose with cord pull with white plastic end (rose over-painted, cord slightly browned)	
<b>Floor</b>	Cream/beige mottled vinyl with chrome door strip (heavy grey water damage running along edge to bath, bubbled and lifting to corners of bath, seal to edge little discoloured, ridged by toilet, seal to edge by bath lifting and discoloured, tired condition)	
<b>Heating</b>	Single off white panelled radiator (scuffed and scratched to top, discoloured to fittings)

ITEM	DESCRIPTION (CONDITION)	COMMENTS IN/OUT
<b>Bath</b>	Light pink plastic with 2 chrome bar handles, chrome mixer tap with chrome flex and shower head, chain and plug, magnolia painted hardboard bath panel with dark wooden trim (soak away slightly scaled, seal around edge of bath slightly messy, scuffing and run marks to side and end panel)	
<b>Sink</b>	Terracotta coloured ceramic basin and pedestal with 2 chrome/brown taps with chain and plug (white staining around soak away and around taps with over-paint, seal to back slightly cracking, otherwise clean)	
<b>Toilet</b>	Terracotta matching cistern and pan with chrome flush, pine varnished seat and lid (scratch line mark to top of toilet seat lid, top of pan dirty, pan stained, water marking to underside of seat, requires additional cleaning)	
<b>Shower</b>	Chrome inset shower unit into panel with chrome shower head, white shower rail with white shower curtain with white rings (chrome lightly mottled and water marked, light staining to bottom of curtain)

<b>Built-in Cupboard</b>	Light wood grained sapel with 2 chrome lever handles, chrome round plate either side (over-paint to edge on inside, white plastic coated hook to top on outside, water marked to outside), inside yellow lagged water tank sitting on white painted wooden shelf, 2 light wood MDF shelves, light wood slatted shelf (slight debris to shelf where tank is, walls all slightly marked, staining/dirty to floor)	
<b>Misc.</b>	White metal towel rail (coming away from wall on r/h side) Oval shaped mirror attached to wall (slightly silvered to edges, dusty) Cream plastic toilet roll holder (dusty) Pine effect MDF medicine cabinet with 2 mirrored sliding doors with brass round handles; inside single shelf (odd light over-paint to wood, white staining to selves inside, glass smeared)
